PAINT ADHESION FAILURE CHARACTERISATION

Subject: Crater formation on a paint due to a wettability defect of the paint on a primer.

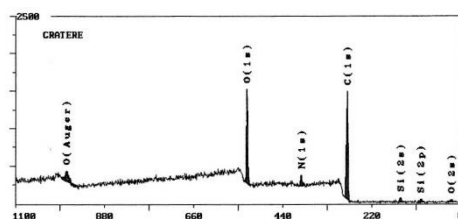
XPS spectrum in the crater

| at.% | C | O | N | Si |
| crater | 73 | 22 | 3 | 2 |
| outside crater | 74 | 23 | 3 | - |

- ✓ By XPS : adhesion failure due to surface contamination by a siloxane compound
- ✓ By ToF-SIMS : PolyDiMethylSiloxane (PDMS) contaminant
